model 5800VRKT

Valve Repair Kit

MODEL(S): 5800VRKT VALVE REPAIR KIT
 INFO FAX DOC # 25800855
 SCALE: N/A DRAWING TYPE: INSTALLATION/REPAIR

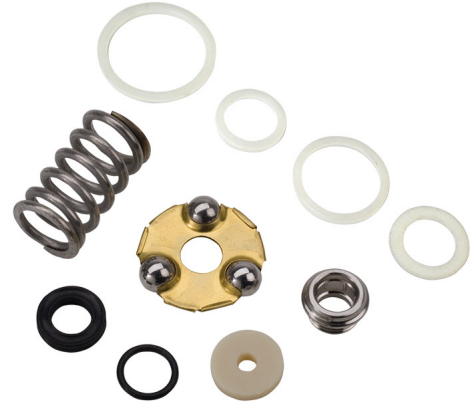
Model 5800VRKT valve repair kit contains a bearing set, gland packing, spring washer, spring, renew seat, seat washer, seat o-ring, bonnet washers and bottom cap washer. Model 5800VRKT is used on models 5830LF, 5051LF, 5054LF, 5057LF, 5060LF, 5851LF, 6250LF, 6252EHLF and the 5452LF. Used on models made in 2005 and newer.
